# Manhole Inspection Summary

Manhole # S05UU1007MH

Insp Date: **9/26/06 9:15 AM**

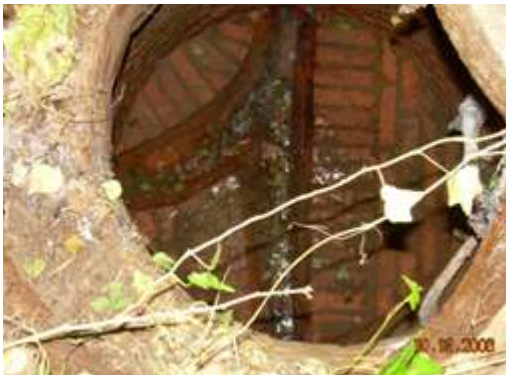
Top View

Frame offset. Adjustment and Corbel infiltration. Bench debris. Channel debris. Corroded steps.

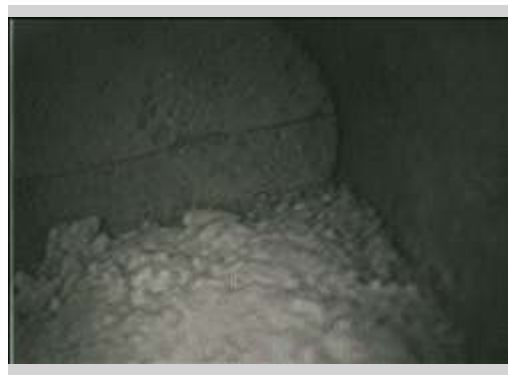
Inside the I9

Stub.

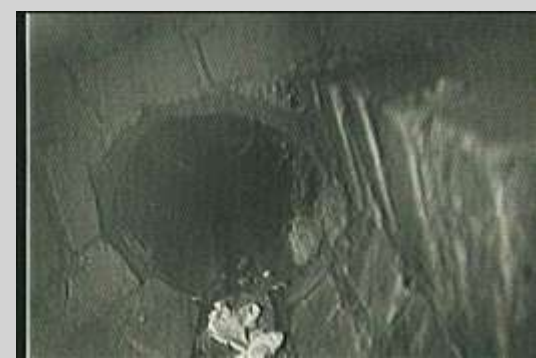
### 8 in. Circular Gravity Sewer Pipe Out @ 12 O'Clock

Deposits: ☐ None ☒ **Mud** ☐ Sludge ☒ **Debris** ☒ **Grease**

Silt Depth: **0** (in.) Deposits Extent: **Light**

Infiltration: **Evidence** Pipe Seal Cond: **Unknown**

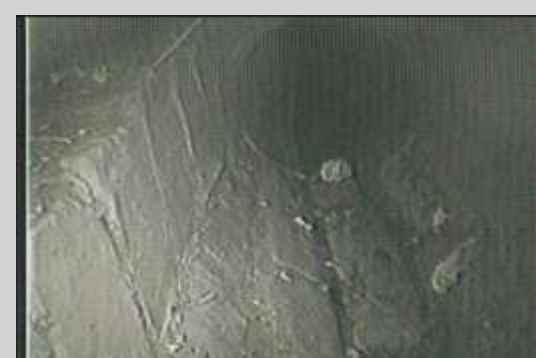
### 8 in. Circular Gravity Sewer Pipe In @ 6 O'Clock

Deposits: ☒ None ☐ **Mud** ☐ Sludge ☐ **Debris** ☐ Grease

Infiltration: **None** Pipe Seal Cond: **Unknown**

Connects To: **Dead End**

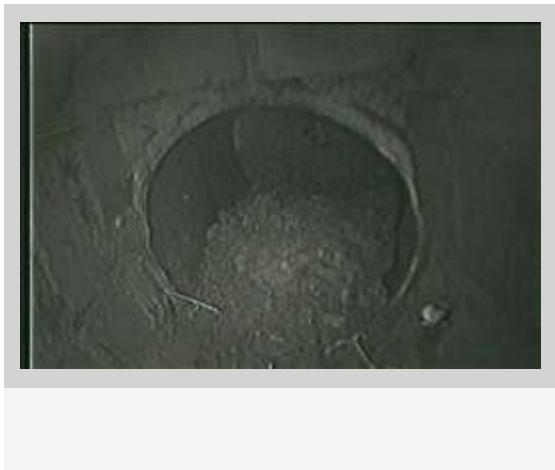
8 in. Circular Gravity Sewer  
Pipe In @ 9 O'Clock

Deposits: ☐ None ☒ **Mud** ☐ Sludge ☒ **Debris** ☐ Grease

Silt Depth: **2** (in.) Deposits Extent: **Medium**

Infiltration: **Evidence** Pipe Seal Cond: **Roots**

Connects To: **Stub connection / abandoned**
